HAMMERFEST  
NORWAY

(19-2) 30 SEP 11

FLORØ  
NORWAY

(19-2) 11 MAR 16

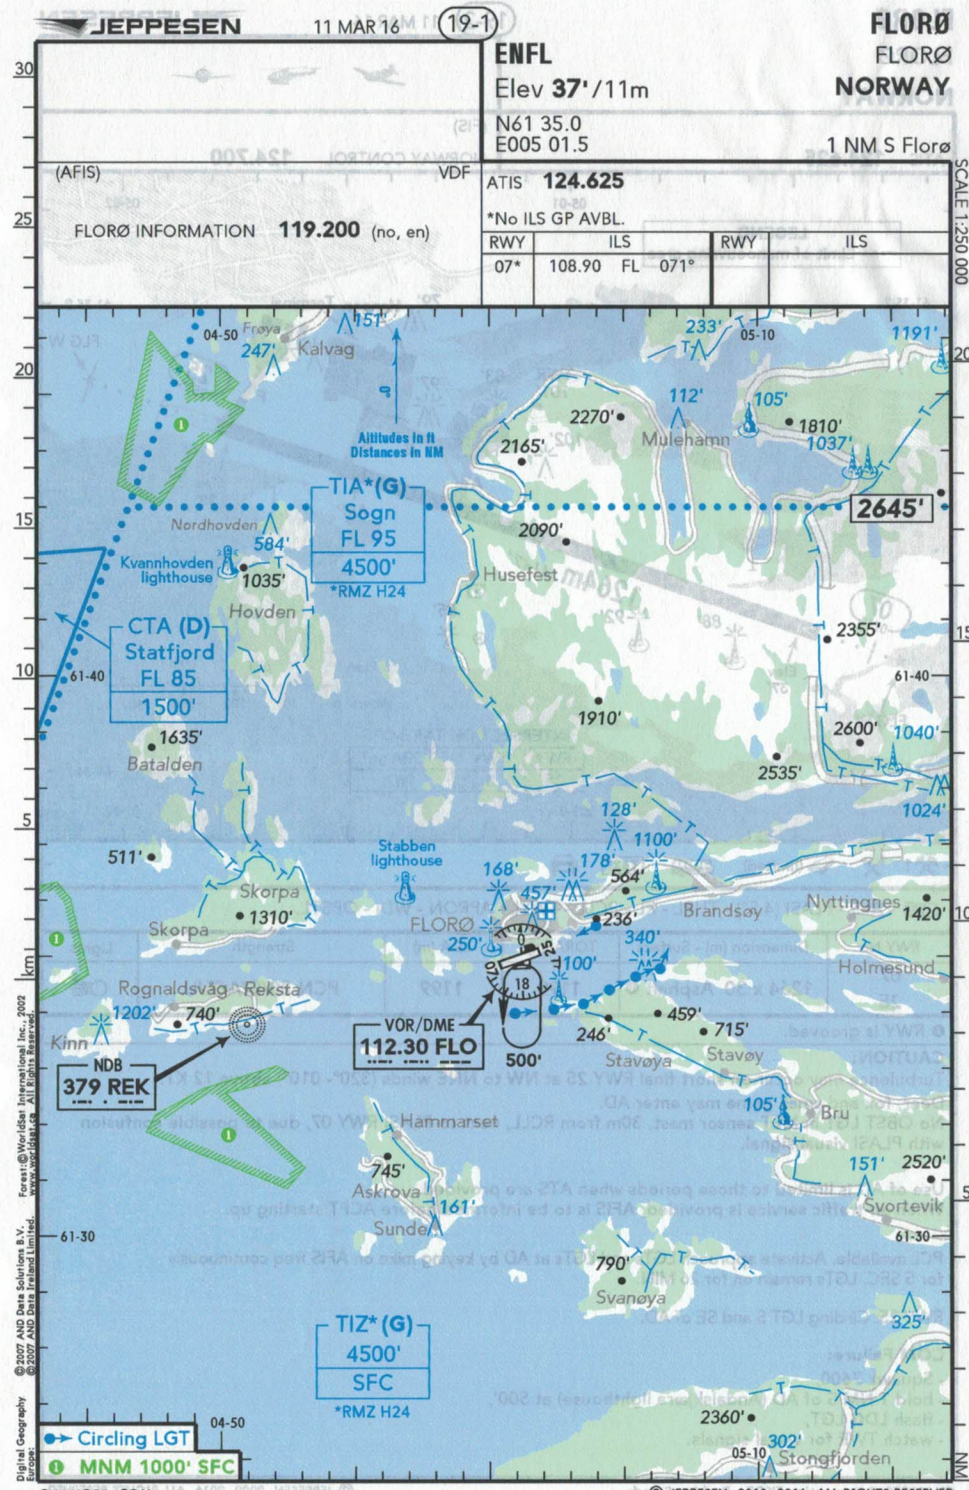
Turbulence/wind shear/downdraft may occur on final RWY 05 and 23. Wind 280°-030° and 120°-190°. Moderate, occasionally severe turbulence, may occur on short final RWY 05 and 23. Wind 280°-030° and 120°-190°. 15 KT or more.

Severe turbulence may occur on short final RWY 05 and 23. Wind 290°-360°, 20 KT or more.

Large bird concentrations (seagulls) may occur during summer season, mainly N of RWY.

PCL AVBL. Activate ALS and RL by keying mike on AFIS frequency continuously for at least 5 seconds. Lights remain on for 26 MIN.

- Squawk 7600,
- hold 1 NM S of THR 05 at 1200',
- flash LDG LGT,
- watch TWR for visual signals.
